Contract #: 04-0120F4Cty: SF/ALA Rte: 80 PM: 13.2/13.9File #: 69.28**WELDING INSPECTION REPORT****Resident Engineer:**Siegenthaler, Peter**Address:** 333 Burma Road**City:** Oakland, CA 94607**Report No:** WIR-021649**Date Inspected:** 10-Mar-2011**Project Name:** SAS Superstructure**OSM Arrival Time:** 700**Prime Contractor:** American Bridge/Fluor Enterprises, a JV**OSM Departure Time:** 1900**Contractor:** Zhenhua Port Machinery Company, Ltd (ZPMC), Changxing Island **Location:** Shanghai, China**CWI Name:** Li Yang**CWI Present:** Yes No**Inspected CWI report:** Yes No N/A**Rod Oven in Use:** Yes No N/A**Electrode to specification:** Yes No N/A**Weld Procedures Followed:** Yes No N/A**Qualified Welders:** Yes No N/A**Verified Joint Fit-up:** Yes No N/A**Approved Drawings:** Yes No N/A**Approved WPS:** Yes No N/A**Delayed / Cancelled:** Yes No N/A**Bridge No:** 34-0006**Component:** OBG Segments**Summary of Items Observed:**

On this date Caltrans OSM Quality Assurance (QA) Inspector, Dan Hernandez was present during the times noted above to observe the fit up, welding and related activities associated with the fabrication of the San Francisco Oakland Bay Self Anchored Suspensio

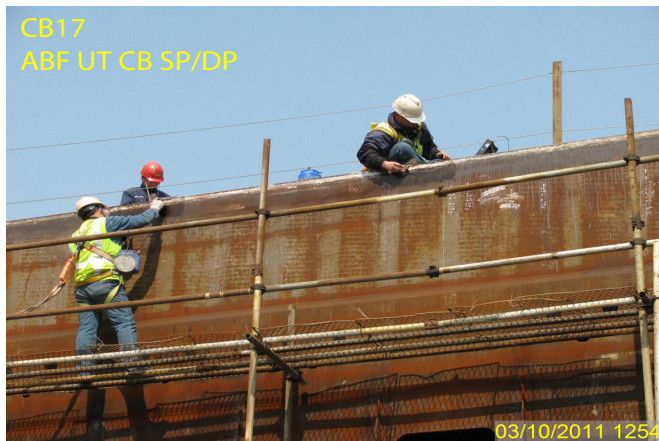
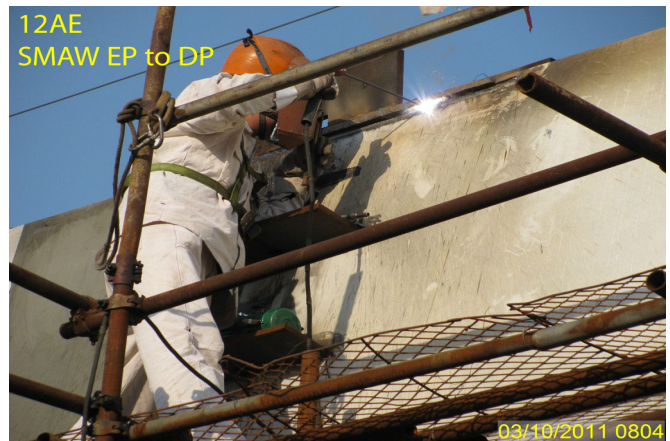
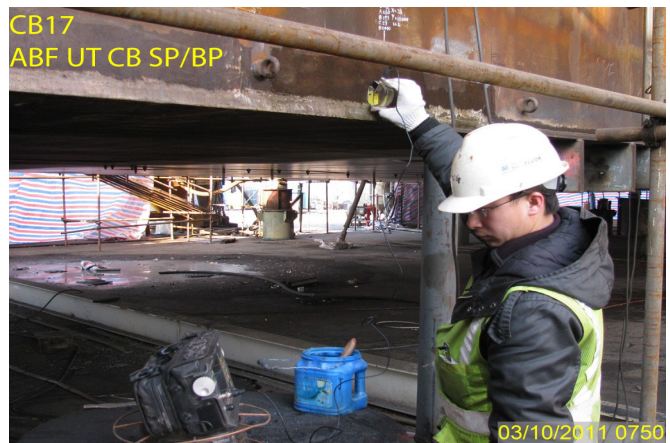
This QA Inspector observed Shielded Metal Arc Welding (SMAW) in progress of a UT repair on a Complete Joint Penetration (CJP) weld joint. The Weld joint is designated DP3018-001-022, Longitudinal Diaphragm to Deck Plate. The welder is identified as #067752 and was observed welding in the 4G (overhead) position using approved Welding Procedure Specification WPS-345-SMAW-4G (4F)-FCM-repair-1, for WR20362.

This QA Inspector observed Shielded Metal Arc Welding (SMAW) in progress of a fillet weld joint. The Weld joint is designated CA3003C-099, horizontal stiffener on Corner Assembly Diaphragm. The welder is identified as #040720 and was observed welding in the 2F (horizontal) position using approved Welding Procedure Specification WPS-B-P-2112-FCM-1.

This QA Inspector observed Shielded Metal Arc Welding (SMAW) in progress of a fillet weld joint. The Weld joint is designated SEG300D-132, 133, Floor Beam web to Side Plate. The welder is identified as #069894 and was observed welding in the 3F (vertical) position using approved Welding Procedure Specification WPS-B-P-2113-FCM-1.

This QA Inspector observed tightening of high strength bolts using the turn of nut method on the Bottom Plate WT connection clip to Floor Beam web at panel point 116.5.

This QA Inspector observed the removal of temporary stiffeners from the web of the FL3 at panel point 112 by arc gouging.

Unless otherwise noted, all work observed on this date appeared to generally comply with applicable contract documents.
